Resolving risks and wider issues following a landslip

Amey Infrastructure Wales

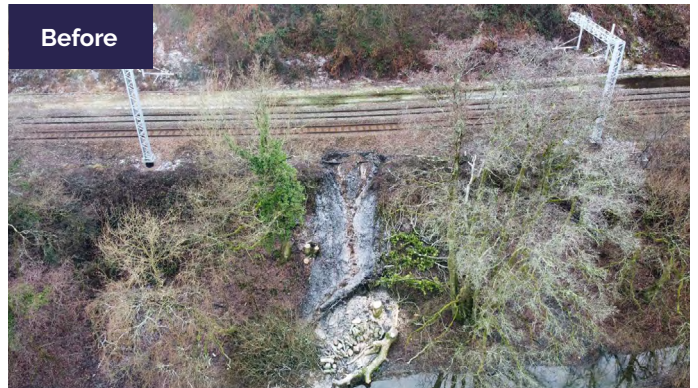
Before

In January 2023, Amey Infrastructure Wales (AiW) alerted us to an embankment failure on a Saturday morning via our reactive emergency call-out framework. Heavy rainfall had caused groundwater to seep through the substrate below the track, washing away the fine material that comprised the adjacent embankment. Where the railway line curved, the embankment had fallen away, leaving the ends of the sleepers unsupported and creating a hazard for operational use.
